RISK ASSESSMENT OF AN UNSTABLE CLIFF ABOVE A HOUSING ESTATE IN VULLY-LES-LACS, SWITZERLAND

MANAGEMENT OF RESIDUAL RISKS FOR THE CANTONAL ROAD RC 502c

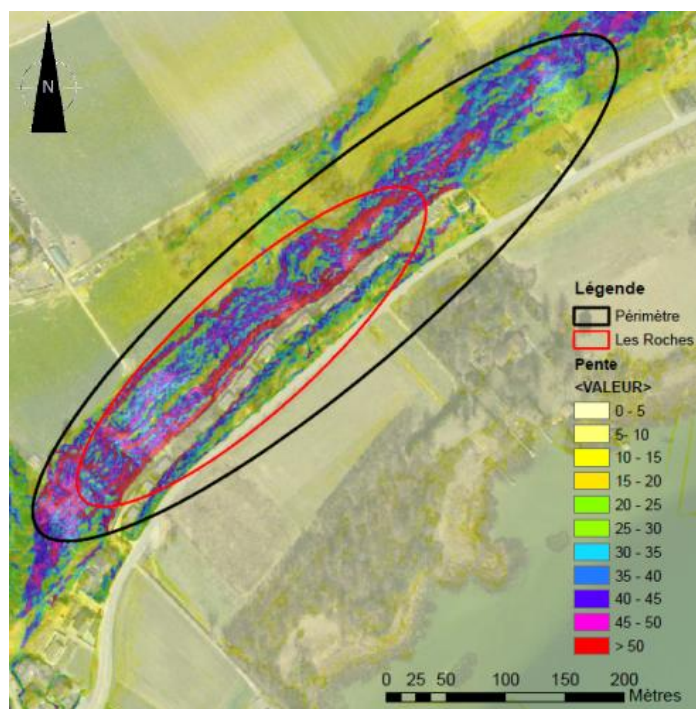
The particularity of this case study is the slope. It is very significant in some places and can reach 50° . Indeed the steeper the slope, the more dangerous the area. Numerous rockfall events were listed when the slope exceeds 40° . Figure 3 shows the difference of slope in the studied area.

Fig. 3: Slope map (values in $^\circ$)

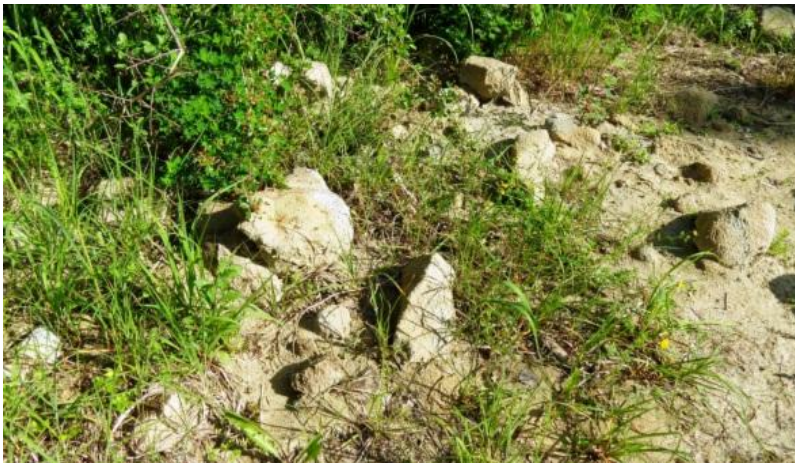
The main danger here is the rockfall. In our case, we have all sizes of rocks, yet they do not exceed 1 m^3 . Indeed, the sandstone and the marl rocks are very crumbly and when they touch the floor at the toe of the slope, they disintegrate in smaller pieces. Figure 4 shows some rocks that can be found.

Fig. 4: Example of rocks at the toe of the slope

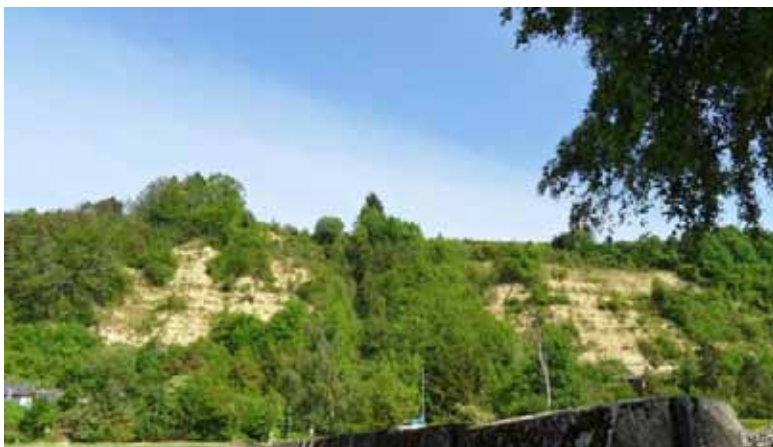
Superficial slides are referred to when the sliding surface is less than 2 m deep. Numerous events of this type are reported in the study site. They are mainly due to high precipitation. Figure 6 shows the scars due to superficial slides.

Fig. 6: Scars due to superficial slides

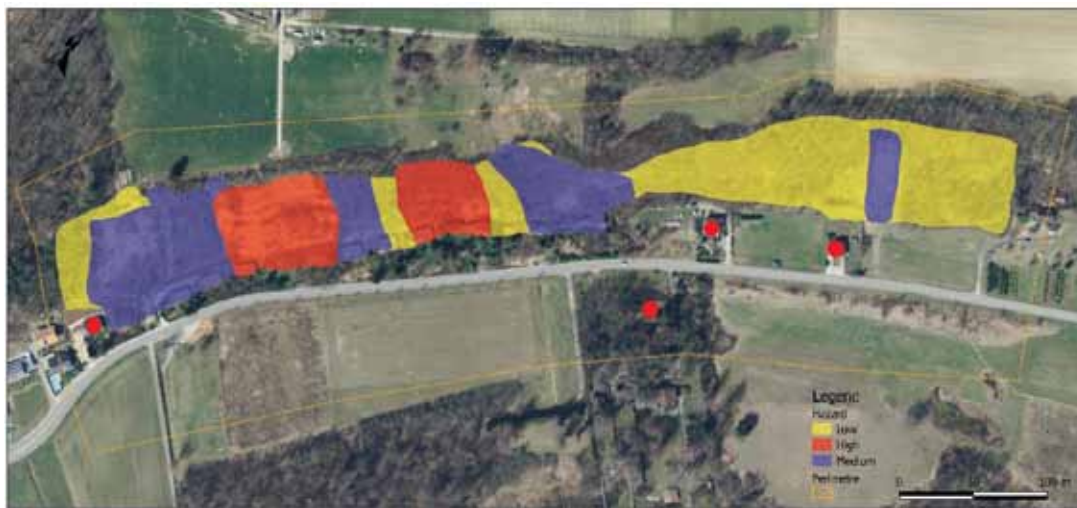
The final hazard map is the result of three different maps, carried out for each type of phenomenon. These maps were prepared on the basis of the history of the region and of what has been observed on the site during different visits. The different levels (low, medium and high) were applied considering the matrix given in figure 5. When two levels of hazard are superimposed, the highest one is chosen and applied on the map (Swiss federal recommendation). Zones in red are principally due to rockfall phenomena. They are the most significant hazards observed. In blue or yellow are represented areas where either superficial slides or debris flow are observed (see Figure 7).

Fig. 5: Hazard map considering rockfall, superficial slide and debris flow; the red dots indicate the houses still in use.

The houses that are now empty will be destroyed (during these works specific measures will need to be taken to protect workers). A reinforced dike will be built instead of the house, as planned by the authorities. Several reinforced walls will also be built behind the houses which are still occupied. Additionally, several upstream drainage systems may be carried out.

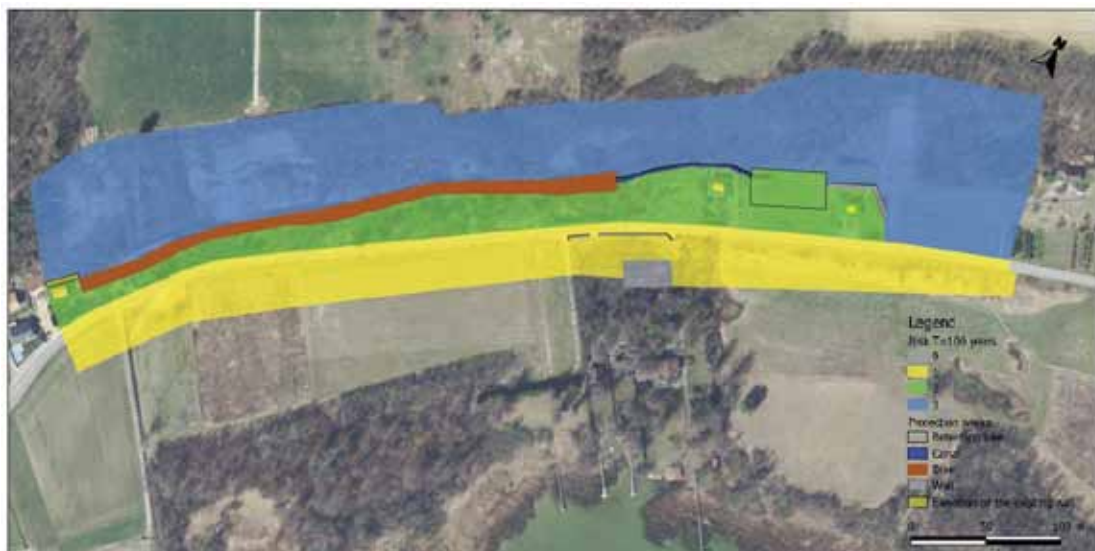
All the risk analysis was also done considering protection works. The same parameters as before were used in order to have representative results. The final analysis shows that an acceptable risk level is reached for phenomena having a return period equal to 100 years. All exposed elements are not directly threatened. The next picture shows the final risk map for an event with a return time of a hundred years, after the construction of the dike.

Fig. 7: Final risk map (T=100 years); the road only incurs residual risks
