High frequency guided ultrasonic waves for hidden fatigue crack growth monitoring in multi-layer model aerospace structures

To cite this article: Henry Chan *et al* 2015 *Smart Mater. Struct.* **24** 025037

Henry Chan¹, Bernard Masserey² and Paul Fromme¹

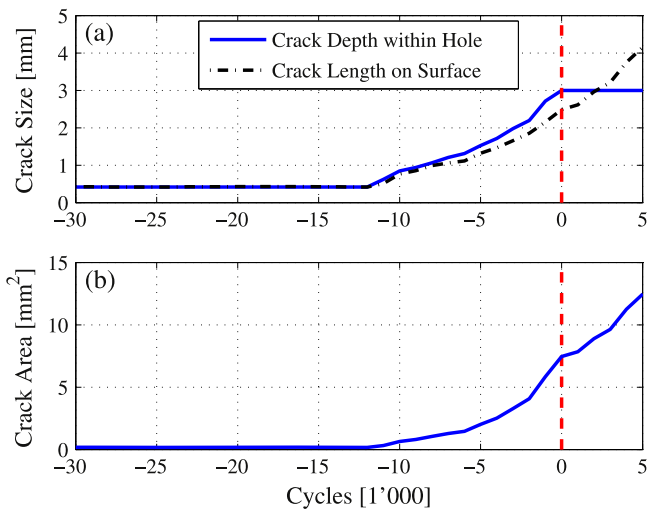
Figure 3. Typical optically measured crack growth during fatigue cycling; (a) crack length (dashed–dotted, black) on specimen surface and crack depth (solid, blue) within fastener hole; (b) crack area; zero cycles (dashed, red) indicates crack through damaged aluminium layer.

The specimens were subjected to cyclic tensile loading in a servo-hydraulic testing machine with the loading axis parallel to the specimen length. For the specimen geometry the stress concentration factor at the side of the through-thickness hole is approximately 2.75 (compared to average stress level). Therefore a maximum load of 54 kN was selected so that the maximum stress in the aluminium plates at the side of the hole was just below the yield strength of the material, to avoid plastic deformation on the undamaged side. The cyclic loading was performed with a stress ratio $R=0.1$ and a cycling frequency of 7 Hz. A small triangular notch (45° to specimen back surface and hole) of approximately 0.4 mm length and depth (range: 0.32–0.54 mm) was introduced using a very fine file at 90° to the axis of tensile loading to prescribe the location of fatigue crack initiation. The stress level at the side of the hole (and starter notch) was well above the fatigue strength of the material. The cyclic loading was interrupted every 1000 cycles, holding the specimen under maximum tensile load to avoid crack closure during the ultrasonic measurements. Further measurements should investigate the relevance of the load (and the resulting crack opening) on the ultrasonic signals and thus detection sensitivity for fatigue cracks. The crack size was measured optically on the damaged specimen surface (crack length) and through the hole thickness (crack depth) by means of an optical microscope. Typical photographs of the observed fatigue crack growth are shown in figure 2 for one specimen.

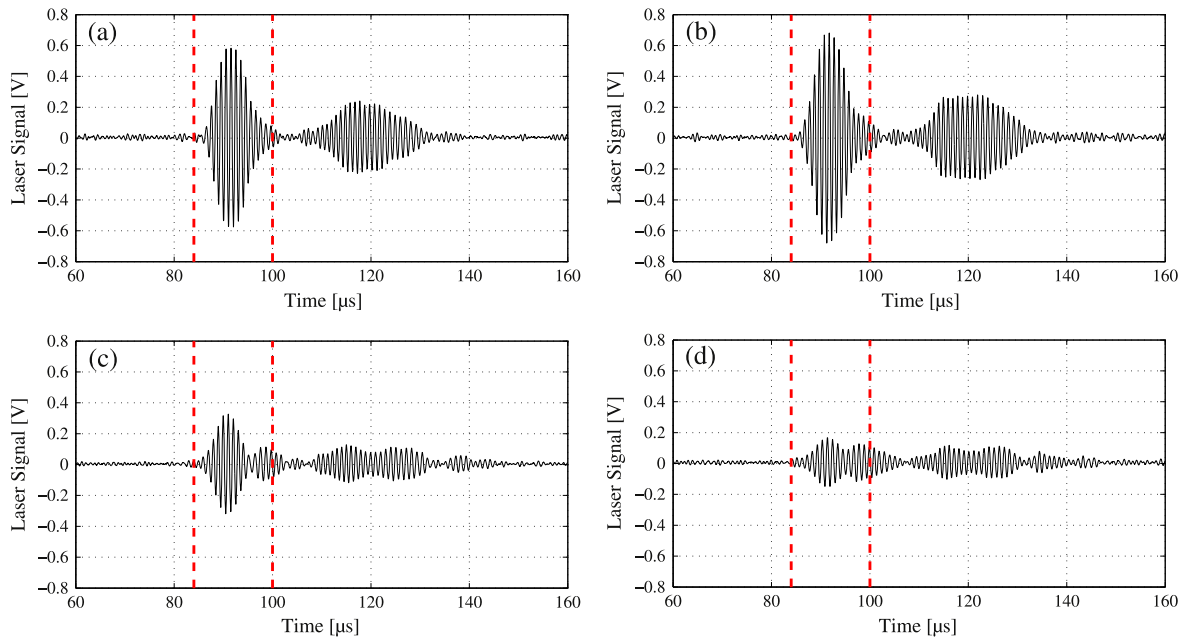
Figure 5. Time traces measured using laser interferometer at location close to fatigue crack; (a) –32 000 cycles (baseline measurement), no crack; (b) –10 000 cycles, crack length 0.77 mm, crack depth 0.85 mm; (c) –5000 cycles, crack length 1.32 mm, crack depth 1.53 mm; (d) zero cycles, crack length 2.49 mm, crack depth 3.00 mm (through aluminium layer); employed time window 85–100 μs indicated (dashed lines).

Fatigue crack growth during cyclic loading was monitored in five specimens using noncontact laser measurements as described in section 2. Typical time traces are shown in figure 5 for the same specimen and crack lengths as in figures 2 and 3.

The strong, initial wave pulse starting at about $85 \mu\text{s}$ in figure 5(a) consists of the fundamental A_0 and S_0 modes and the arrival time matches the theoretical prediction based on their group velocities. The second pulse at about $110 \mu\text{s}$ matches the arrival time of the A_1 mode, but might contain a reflection of the first wave pulse at the side of the specimen. For the purpose of this study a time gate from 85 to $100 \mu\text{s}$ (indicated as dashed lines in figure 5) was used to analyze only the main, initial pulse. The times were calculated based on the wave propagation and the group velocities of the fundamental modes, accounting for the wave propagation time within the wedge. The observed time traces stayed reasonably unchanged during the cyclic loading before a fatigue crack was observed visually. Coinciding with the observation of a small, quarter-elliptical fatigue crack at the side of the hole, an increase in amplitude was observed for all specimens,

as shown in figure 5(b). With increasing size of the quarter-elliptical crack in the aluminium layer, a subsequent drop in amplitude was observed (figure 5(c)). The amplitude drop continued until shortly before the crack grew through the bottom aluminium layer (figure 5(d)), after which some further variation was observed (especially for one specimen).

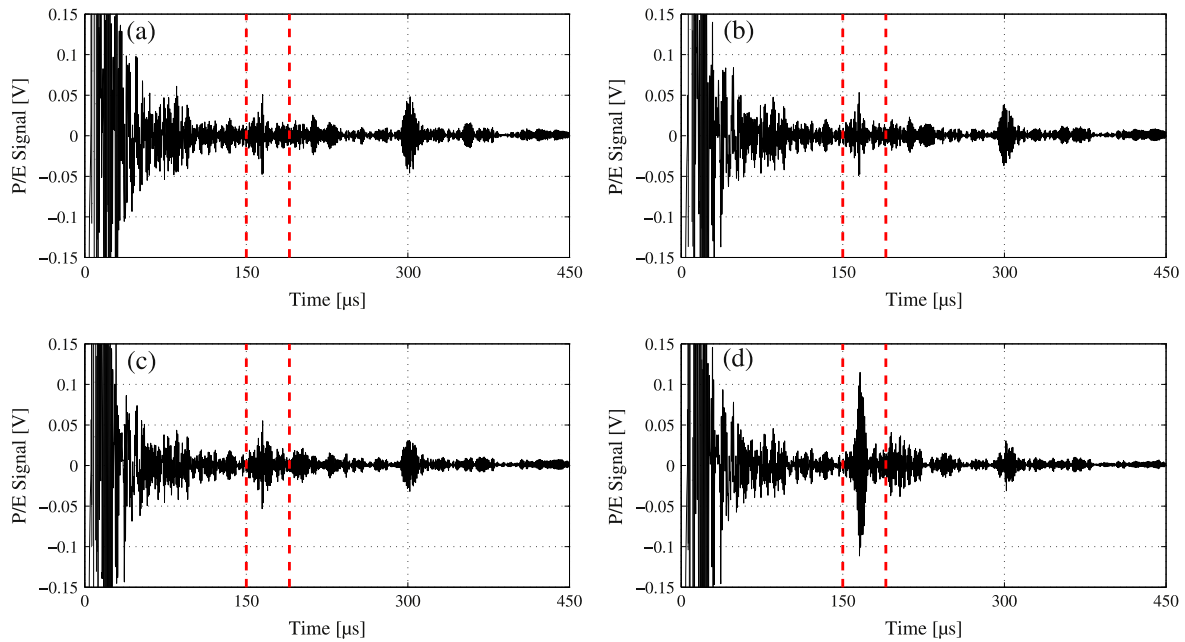
Figure 8 P/E time traces from 225 mm stand-off distance; (a) $-53\,000$ cycles (baseline measurement), no crack; (b) $-12\,000$ cycles, crack length 0.70 mm, crack depth 0.77 mm; (c) zero cycles, crack length 2.57 mm, crack depth 3.00 mm (through aluminium layer); (d) 10 000 cycles, crack length 6.02 mm, crack depth 3.00 mm (through aluminium layer); employed time window 150–190 μs indicated (dashed lines).

The reflection at the undamaged fastener hole (incl. starter notch) is visible in figure 8(a) at about $170\text{ }\mu\text{s}$ as a distinct pulse and the reflection at the end of the specimen at about $300\text{ }\mu\text{s}$. The propagation time was calculated based on the combination of path lengths in the wedge and specimen and the highest and lowest group velocities for the fundamental guided wave modes. Based on this a time window from 150 to $190\text{ }\mu\text{s}$ as indicated by the red, dashed lines in figure 8 was selected to time gate the reflected pulse at the hole and fatigue crack. For a small quarter-elliptical fatigue crack no systematic change above the noise level of the reflected pulse is visible (compare figure 8(b) to the baseline signal in figure 8(a)). Approximately when the fatigue crack had just grown through the damaged aluminium layer a small increase in amplitude of the reflected pulse and change in shape was observed (figure 8(c)). With increasing length of

the fatigue crack through the aluminium layer a significant increase in reflected amplitude can be seen in figure 8(d). This is in line with the observations of the influence of the fatigue crack on the scattered wave field, where only for larger fatigue cracks a significant back-scattered wave pulse was observed. For the five specimens there was more variation of the reflected wave pulse patterns than had been observed for the laser measurements reported above.

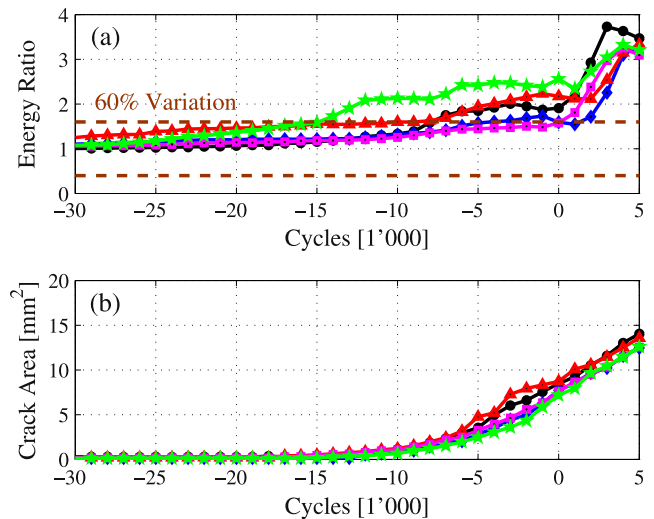
Figure 9. (a) Energy ratio of P/E pulse measured from 225 mm stand-off distance from hole for five specimens (solid lines); 60% amplitude variation shown (dashed); (b) optically measured crack area for five specimens; plotted against number of cycles before crack grown through thickness.

growth measurements for the previous five specimens the crack area measurements for the five specimens in figure 9(b) follow a reasonably similar pattern. For most of the specimens an initial increase of the energy ratio was noted at about $-10\,000$ to $-5\,000$ cycles in figure 9(a). A second, sharper increase to an energy ratio of at least three was observed for all specimens by 4000 cycles, when the crack through the aluminium layer had grown to a length of at least 3.5 mm. The energy ratio versus crack area is shown in figure 10 for simpler interpretation. Up to 60% variation for two of the specimens and 22% variation for the other three specimens
