RISK ASSESSMENT OF AN UNSTABLE CLIFF ABOVE A HOUSING ESTATE IN VULLY-LES-LACS, SWITZERLAND

MANAGEMENT OF RESIDUAL RISKS FOR THE CANTONAL ROAD RC 502c

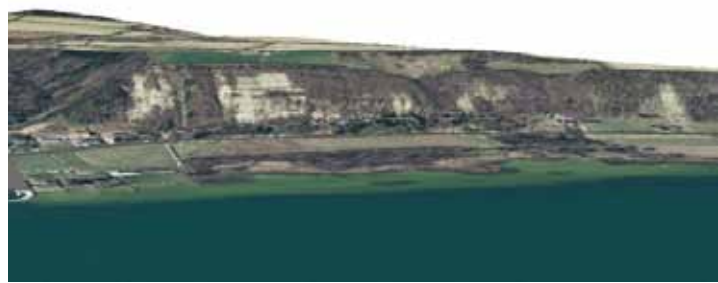
Vully-les-Lacs is a small group of villages of about 2.300 inhabitants in the Canton of Vaud, located some 75 km north of Lausanne. The unstable cliff extends over 500 m on the west coast of Morat Lake (Fig.1). The altitudes of the cliff vary between 450 and 500 m a.s.l. The natural hazards caused by landslides can be seen on a 3D modelled photograph (Fig.2).

Fig. 2: 3D modelled photograph of the study area
