PRINTHEAD NOZZLE STATUS DETECTION

Sebastian Filliger of iPrint, discusses the development of a solution for printhead nozzle status detection, in partnership with STEINEMANN DPE and Polytype AG

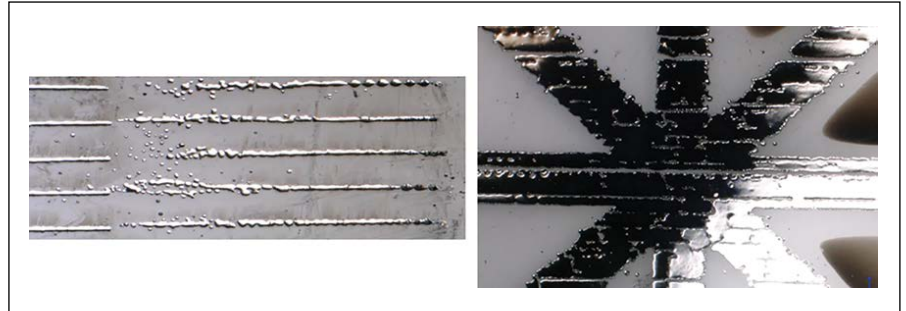
Figure 1: Printing defects caused by the loss of a nozzle

A common issue with printheads is the loss or deviation of a nozzle during printing, which often results in visible product defects (see Figure 1).

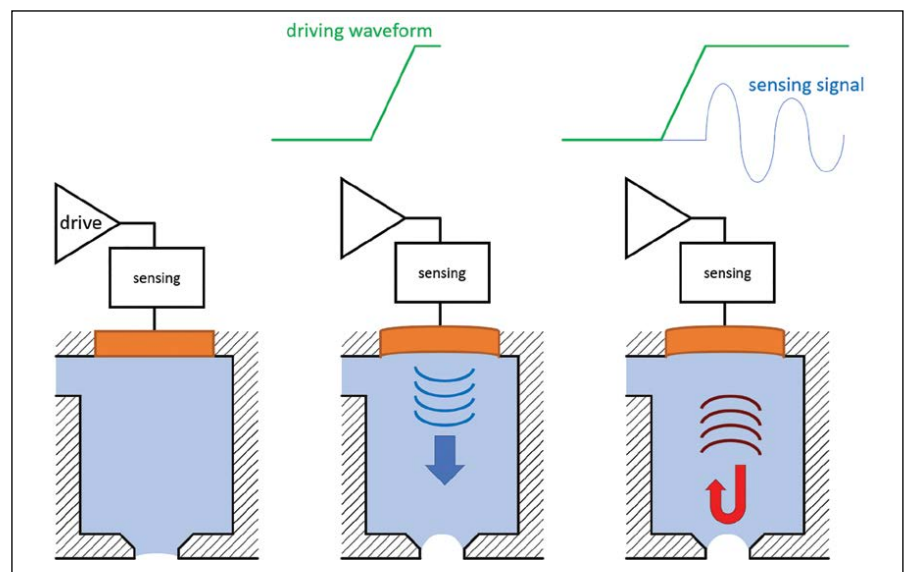
Figure 2: Illustration of the sensing process. The actuator is driven, inducing pressure waves. After activation, the current is measured, yielding a sensing signal

The innovative sensing process uses the nozzle's piezo-actuator as a sensor. The driving of the actuator creates pressure waves within the fluid. These waves bounce back and forth inside the nozzle chamber, exerting pressure back onto the actuator. This results in a small, but measurable, current that is directly proportional to the change of pressure (see Figure 2).

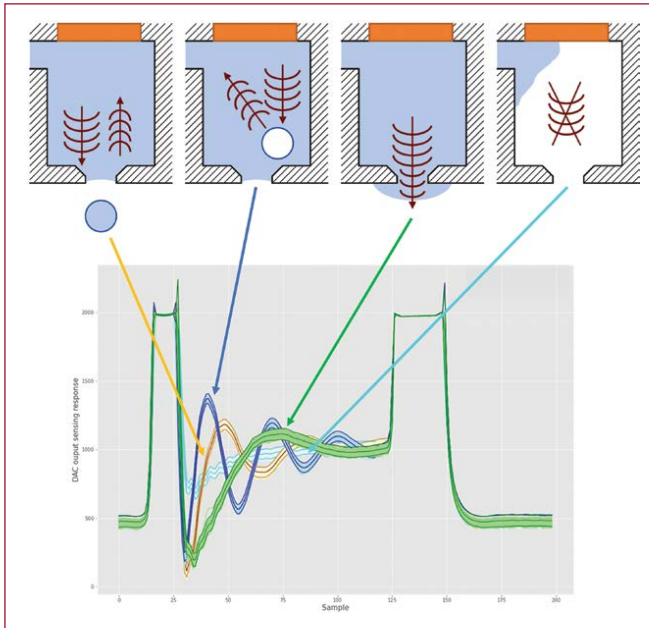
Figure 3: The reflection patterns and corresponding sensing system outputs caused by normal jetting (yellow), an air bubble in the nozzle chamber (dark blue), nozzle plate wetting (green) and nozzle chamber drying (light blue)

In addition to identifying defective nozzles, the sensing system is able to determine the likely cause of the failure. This is made possible by the fact that different nozzle malfunctions change the reflection pattern in a variety of ways (see Figure 3).

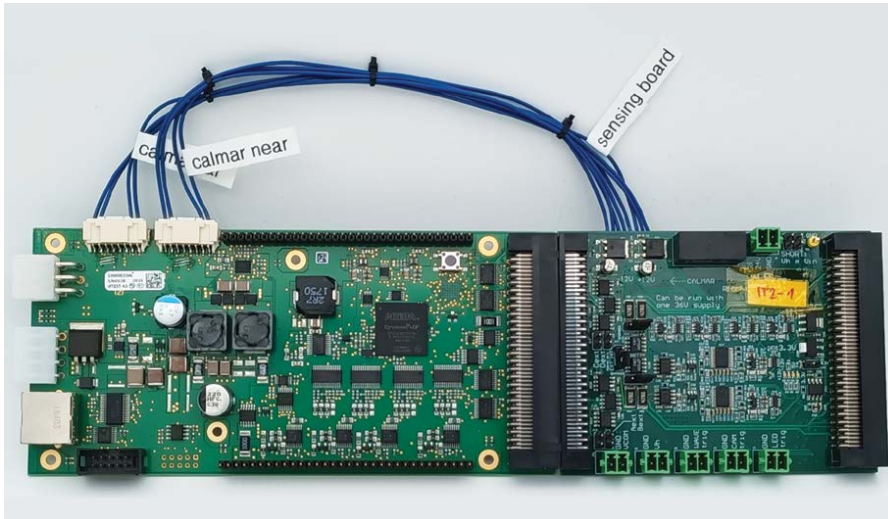
Figure 4: Existing printhead driver board on the left and additional sensing board on the right

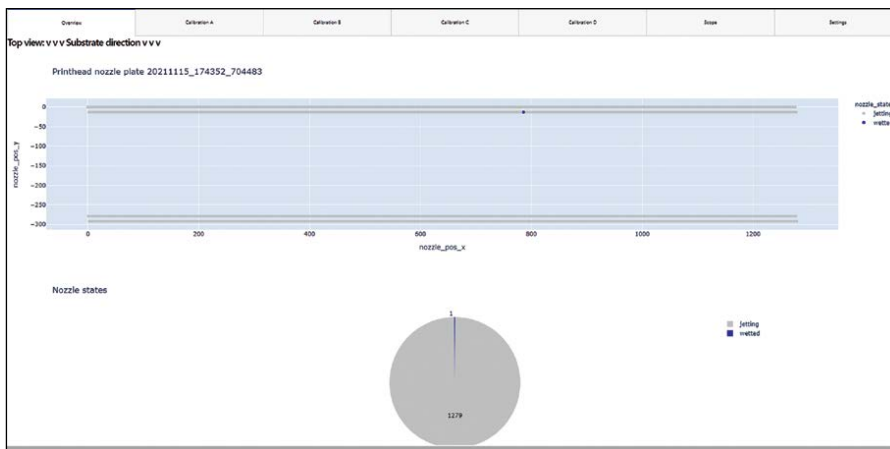
Figure 5: HMI-indicating statistics and positions of missing nozzles

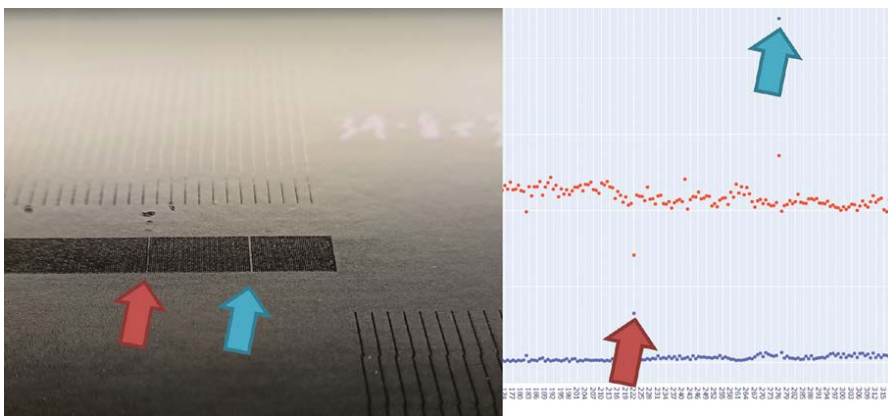
Figure 6: On the left, printing defect caused by a missing nozzle (blue arrow) and by a deviated nozzle (red arrow). On the right, the sensing system's output showing the corresponding outlying fitness values

As shown in Figure 6, the system’s output is easy to interpret. The values produced by well-performing, poorly performing and missing nozzles can be distinguished using simple thresholds.
